# Inspection Report

**Property Address:**  
1234 Park Ave  
San Diego CA 92120

**BHI San Diego / Bailey's Home Inspections**

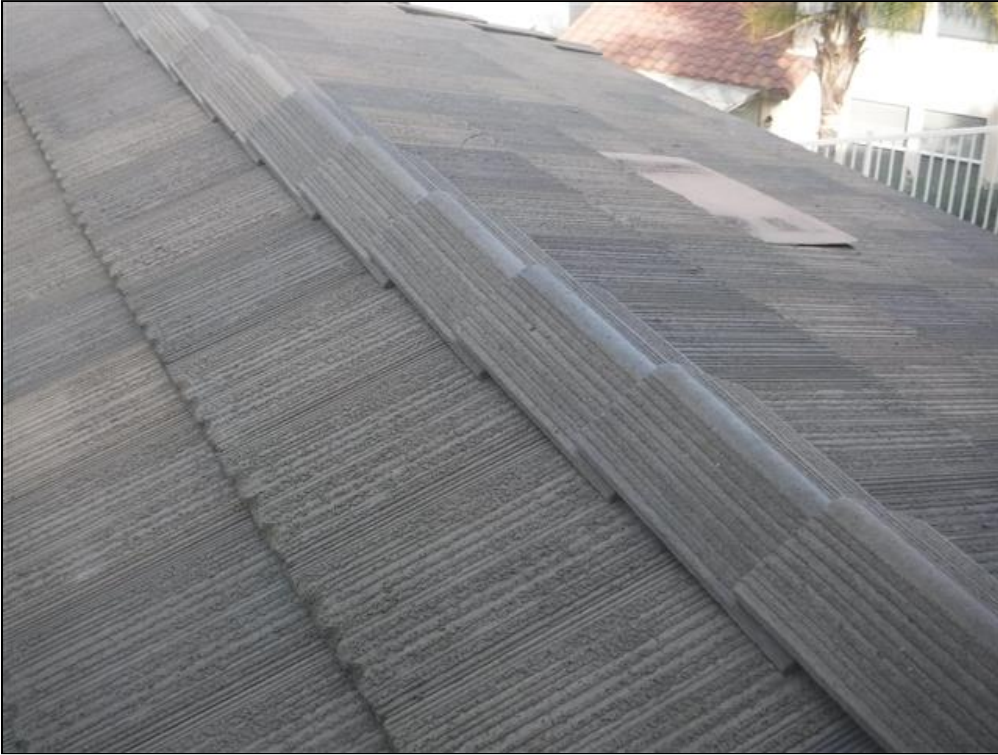
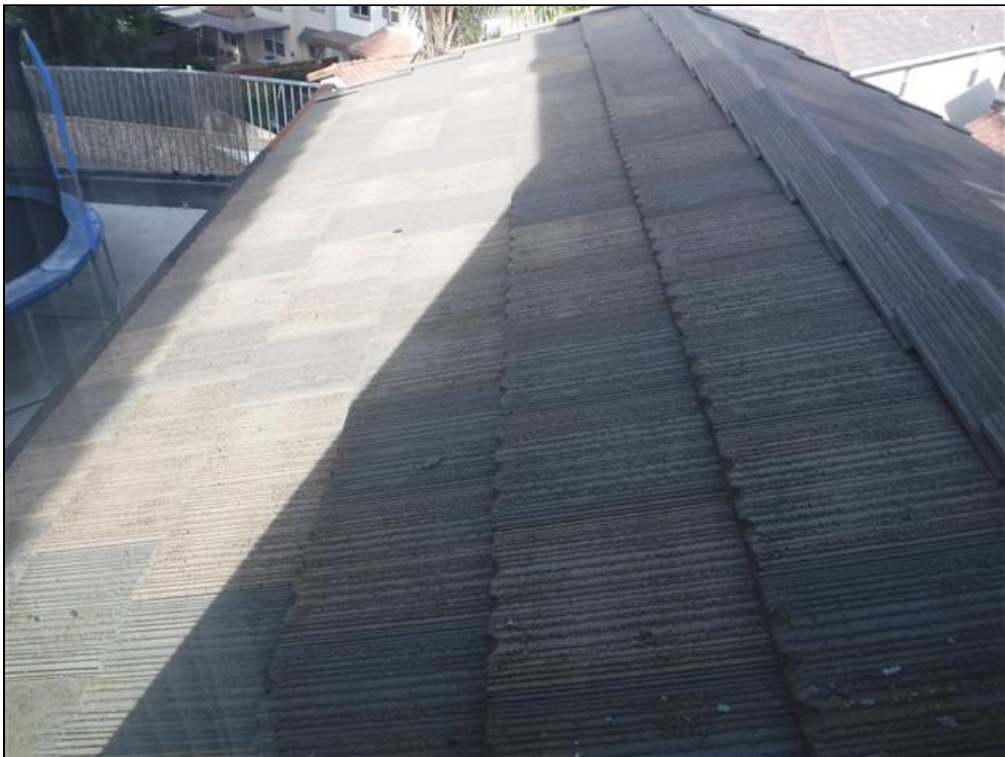
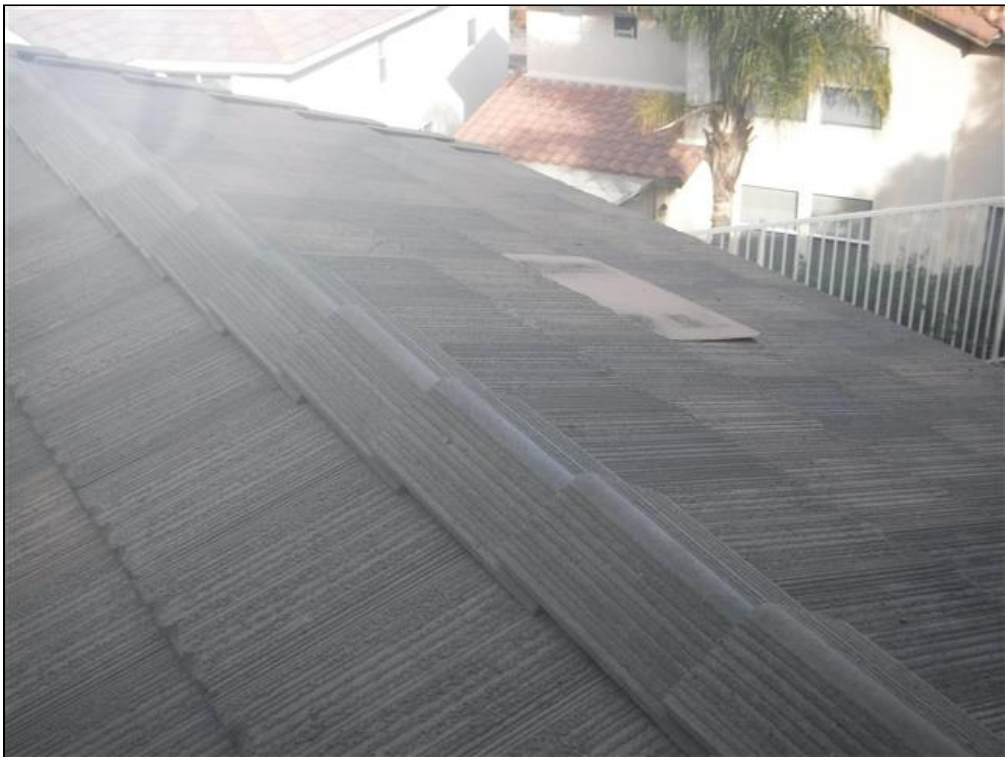
**1.0** As a home inspector I am not allowed to walk on tile roofs. I observed what I could of the roofing from the second story windows and from the ground. No broken, cracked, or slipped tiles observed from second floor windows or from the ground.

1.0 Item 1(Picture) Tile roof covering

1.0 Item 2(Picture) Tile roof covering

1.0 Item 3(Picture) Tile roof covering

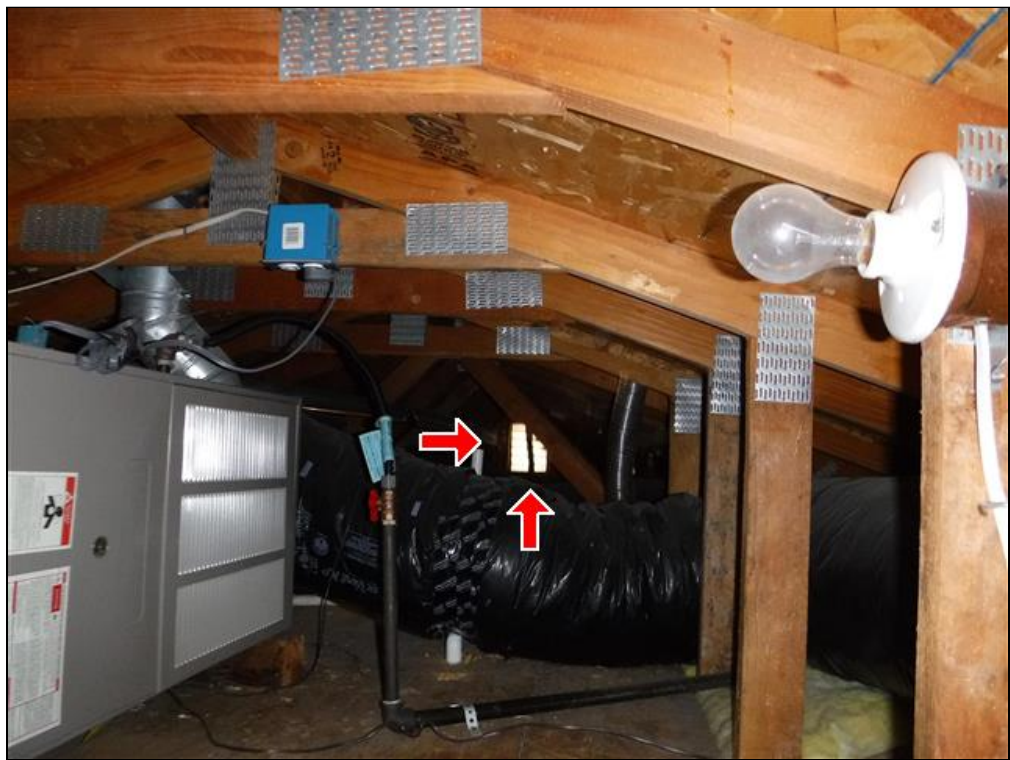
1.2 Gable vents present in attic with screens to keep out birds and other critters.

1.2 Item 1(Picture) Gable Vents in the attic

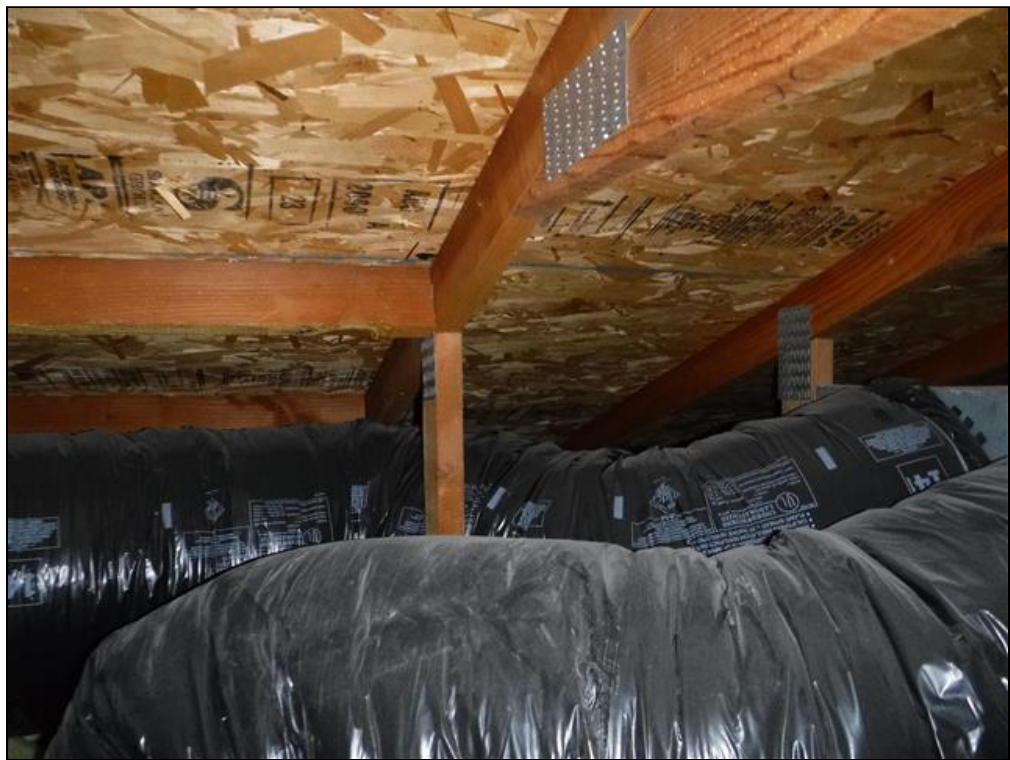
1.4 No signs of water intrusion in the attic.

1.4 Item 1(Picture) No water intrusion in attic

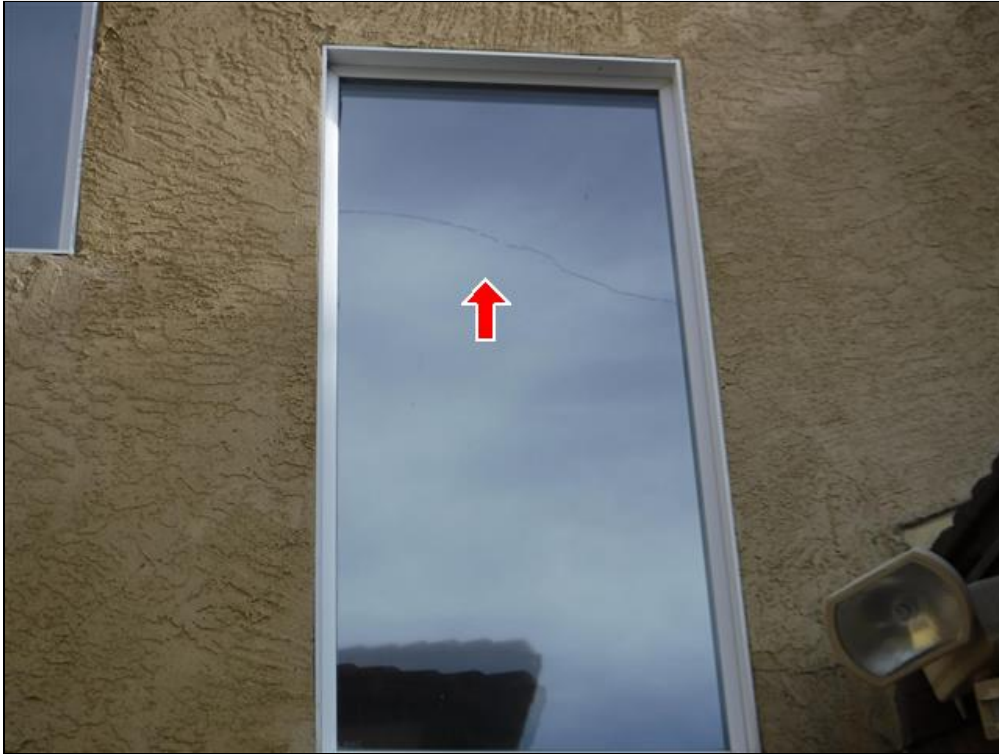
**2.2** There is a window tint on the inside of the windows in the stairwell leading to the upstairs of the house. On numerous windows this tint is bubbling up and cracking. There are numerous windows throughout the house with broken seals. The windows appear to be original to the house. There are broken and bent window screens throughout the house. The window in the master bedroom has a broken track limiting it from being fully opened.

2.2 Item 1(Picture) Window tint bubbling

There is a window tint on the inside of the windows in the stairwell leading to the upstairs of the house. On numerous windows this tint is bubbling up and cracking. There are numerous windows throughout the house with broken seals. The windows appear to be original to the house. There are broken and bent window screens throughout the house. The window in the master bedroom has a broken track limiting it from being fully opened.

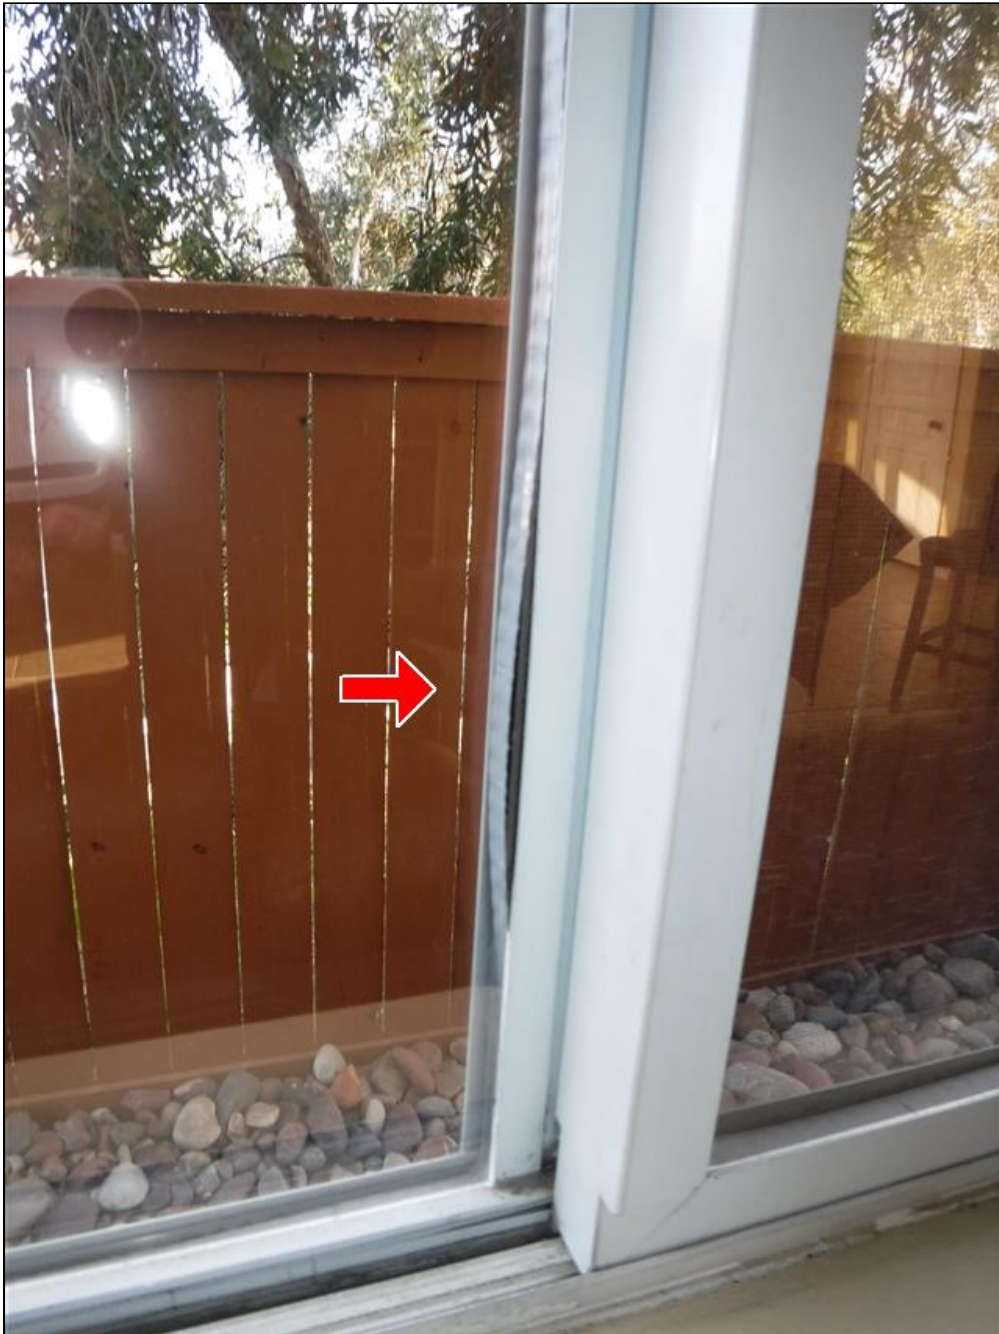
2.2 Item 3(Picture) Broken window seal

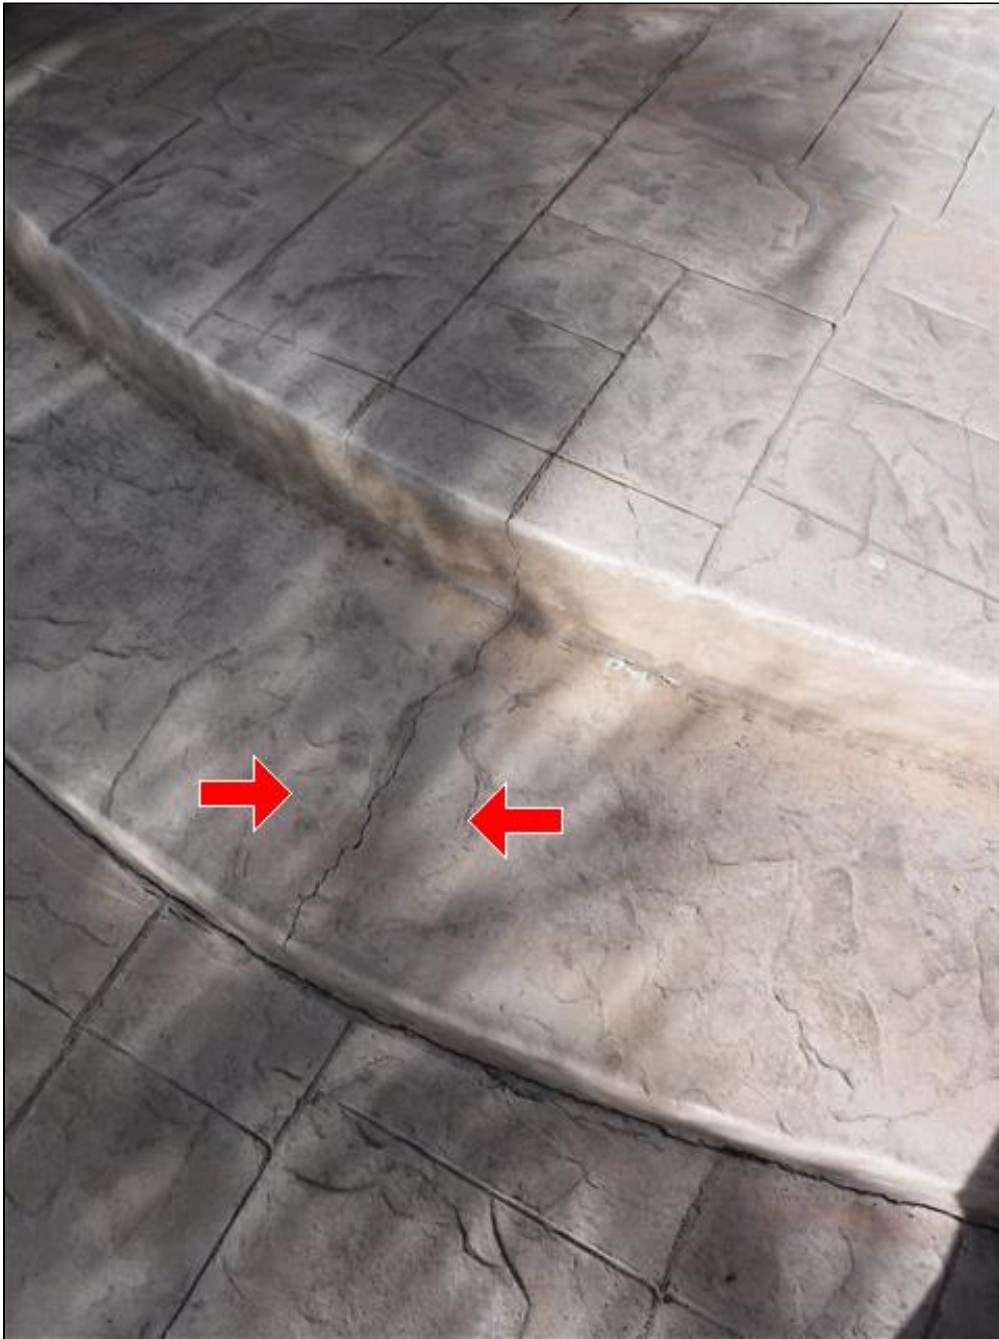
**2.3** There are numerous cracks on the front steps. There is a crack on the front stoop covering the entire width of the stoop. There is some wood rot present on the arbor over the driveway. There is extensive rust on the brackets of the base for the arbor.

2.3 Item 1(Picture) Crack on front steps to house

There are numerous cracks on the front steps. There is a crack on the front stoop covering the entire width of the stoop. There is some wood rot present on the arbor over the driveway. There is extensive rust on the brackets of the base for the arbor.

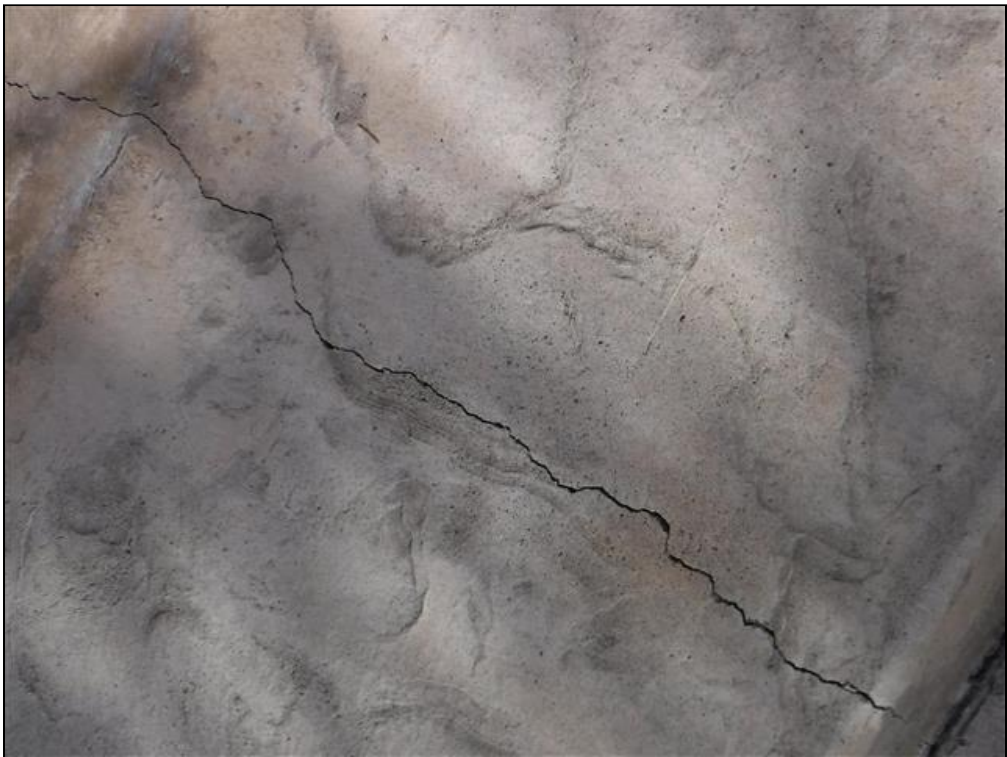
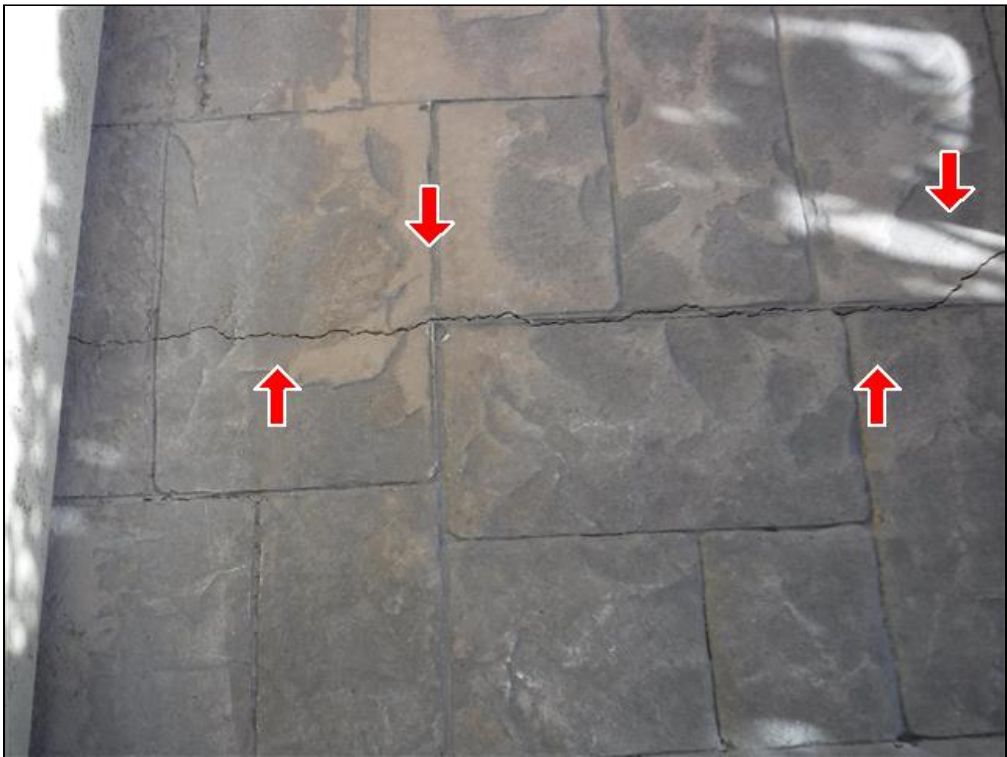
2.3 Item 2(Picture) Crack on the front stoop

2.3 Item 3(Picture) Front stoop crack

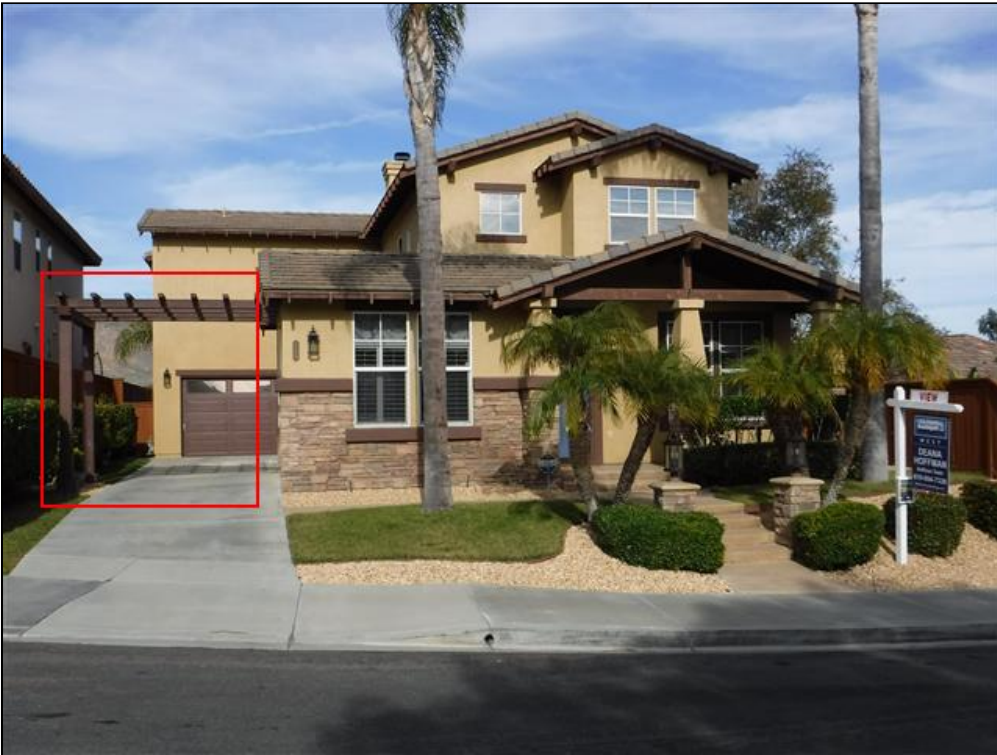
2.3 Item 4(Picture) Arbor

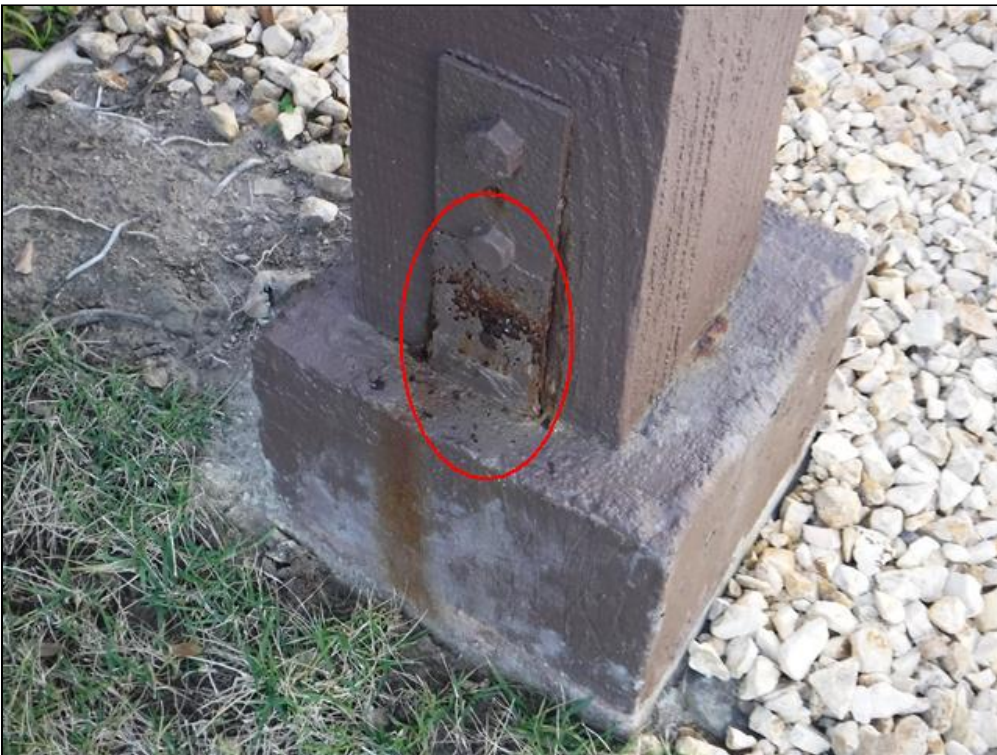
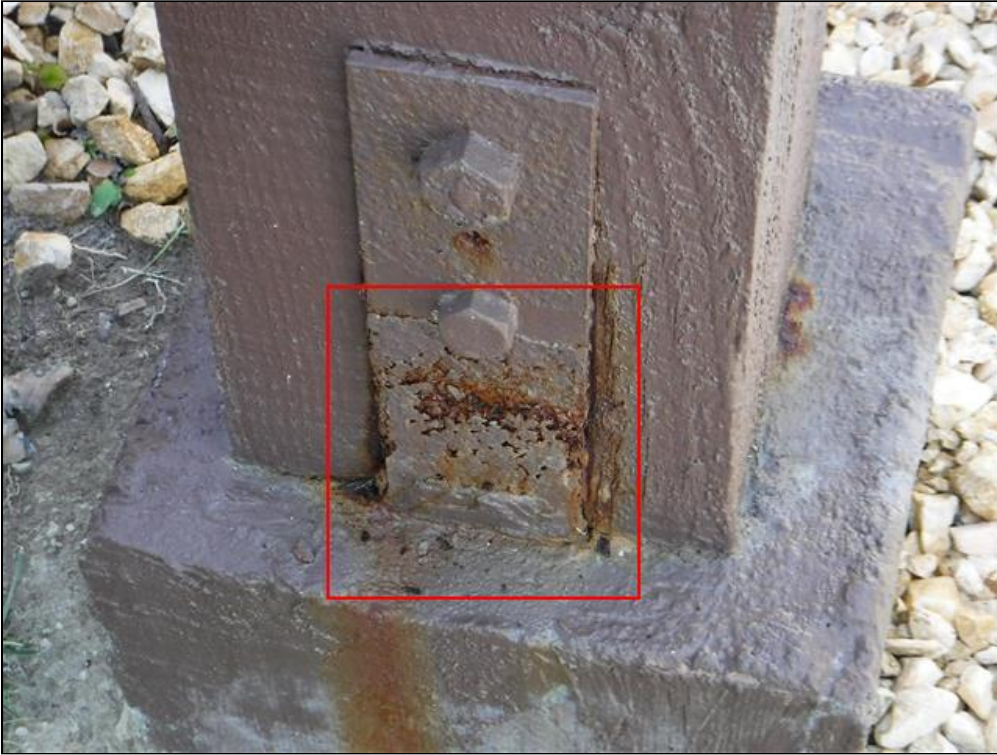
2.3 Item 5(Picture) Rust on brackets

2.3 Item 6(Picture) Rust on arbor bracket

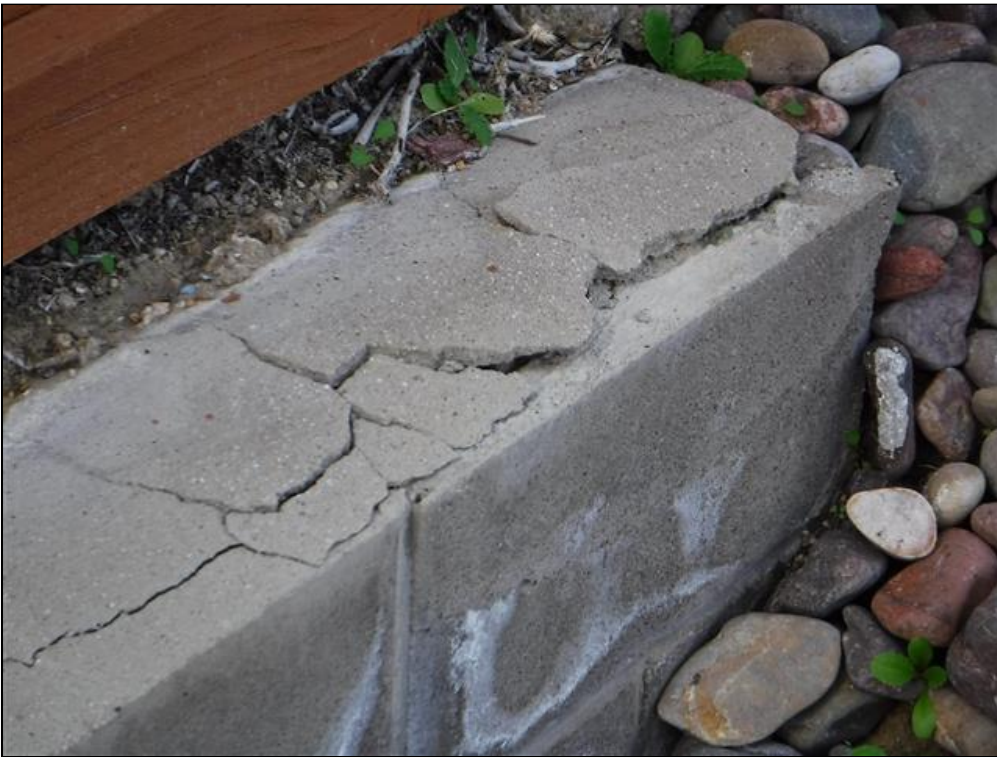
**2.4** The retaining wall on the side of the house shows signs of efflorescence (white powdery deposits). This is a sign of water intrusion. Efforts should be made to identify the source of the moisture and correct this condition to help avoid future damage or crumbling of the retaining wall.

2.4 Item 1(Picture) Retaining wall efflorescence

The retaining wall on the side of the house shows signs of efflorescence (white powdery deposits). This is a sign of water intrusion. Efforts should be made to identify the source of the moisture and correct this condition to help avoid future damage or crumbling of the retaining wall.

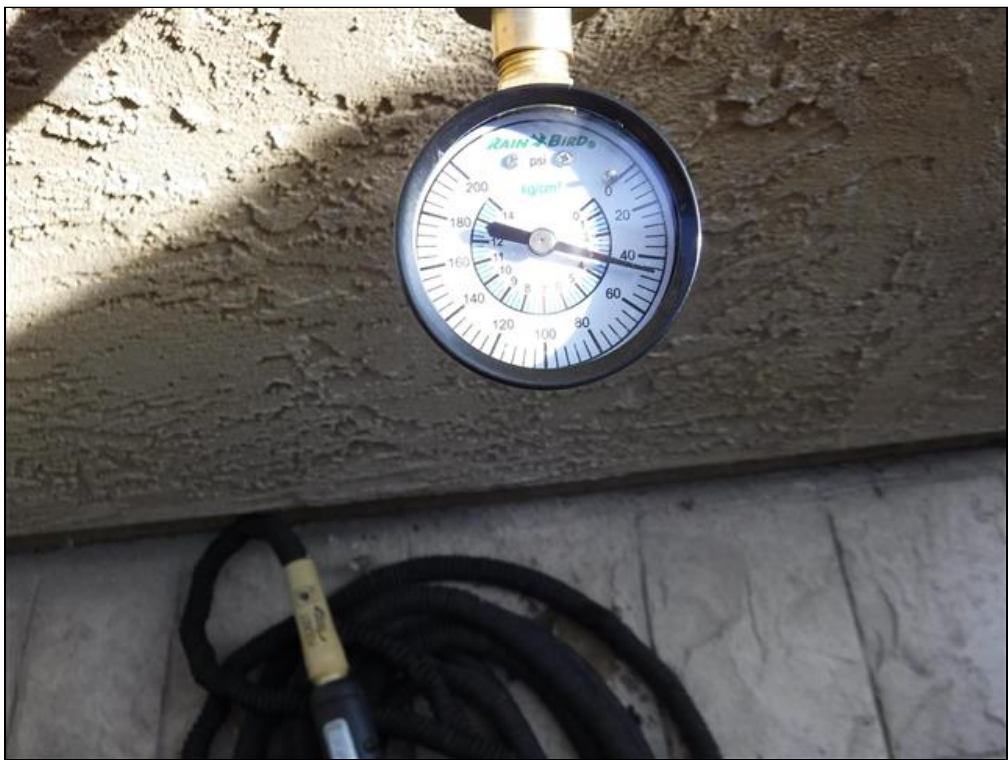
2.6 Ideally the water pressure should be between 60-80 PSI. The hose bibs measured 42 PSI.

2.6 Item 1(Picture) Hose bib water pressure

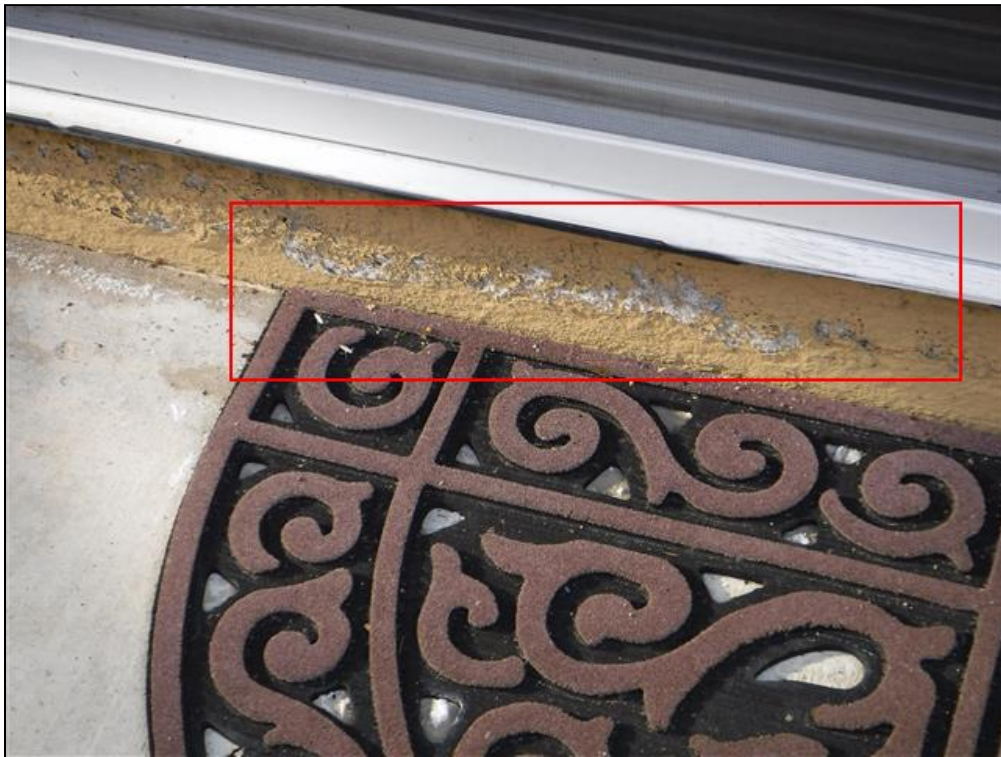
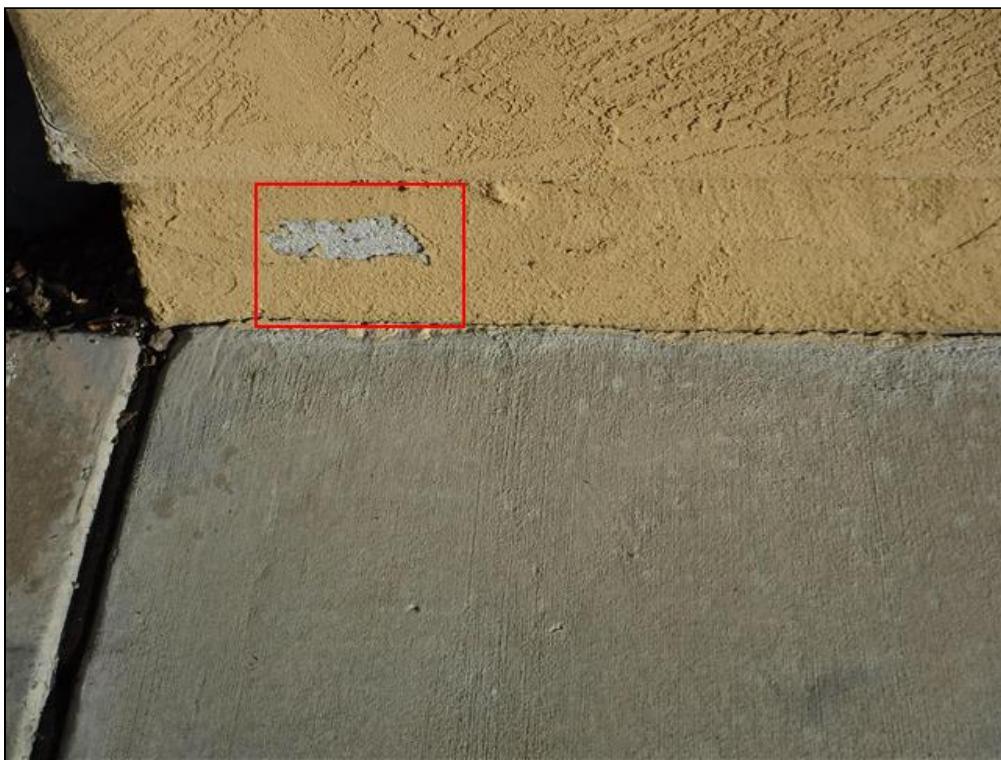
**2.8** The exterior of the slab around the entire house has been painted. There are signs of moisture intrusion, efflorescence, and paint bubbling/chipping.

2.8 Item 1(Picture) Painted exterior slab

2.8 Item 2(Picture) Chipped paint on exterior slab

The exterior of the slab around the entire house has been painted. There are signs of moisture intrusion, efflorescence, and paint bubbling/chipping.

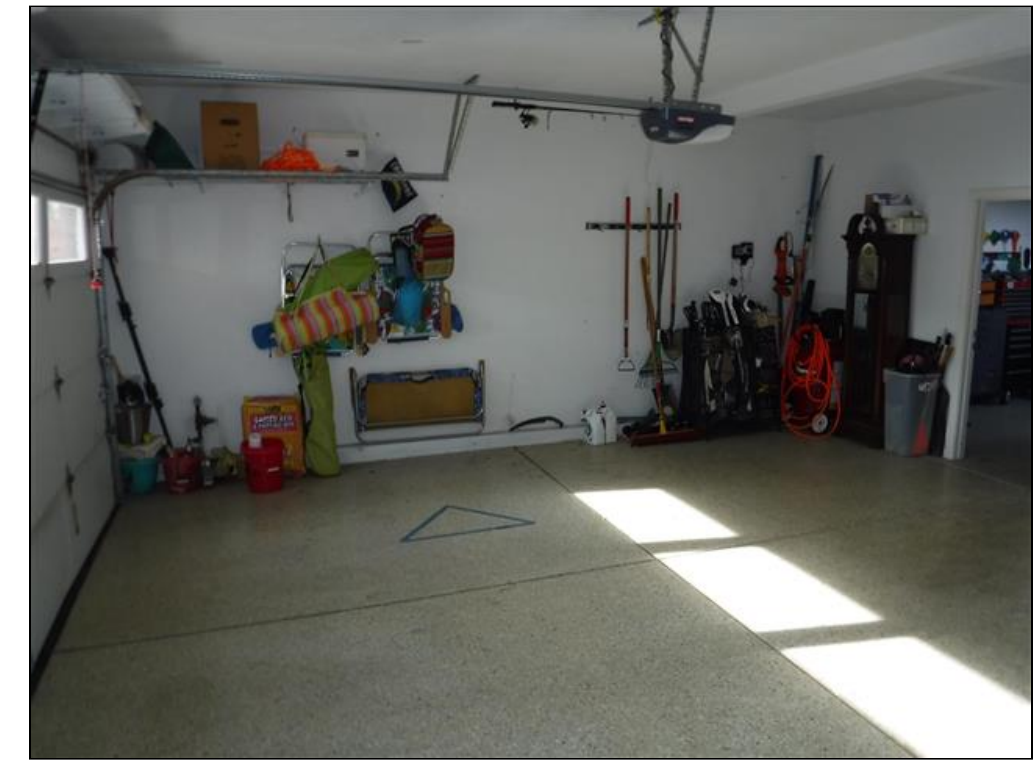
3.2 Epoxy flooring in the garage.

3.2 Item 1(Picture) Garage with epoxy flooring

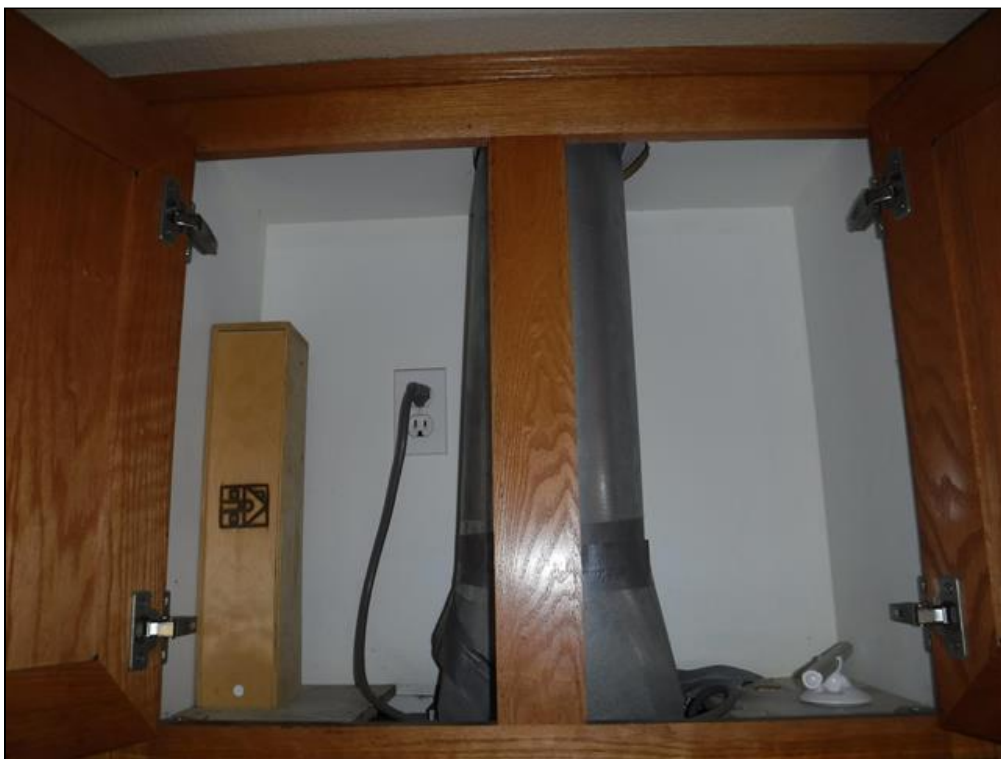
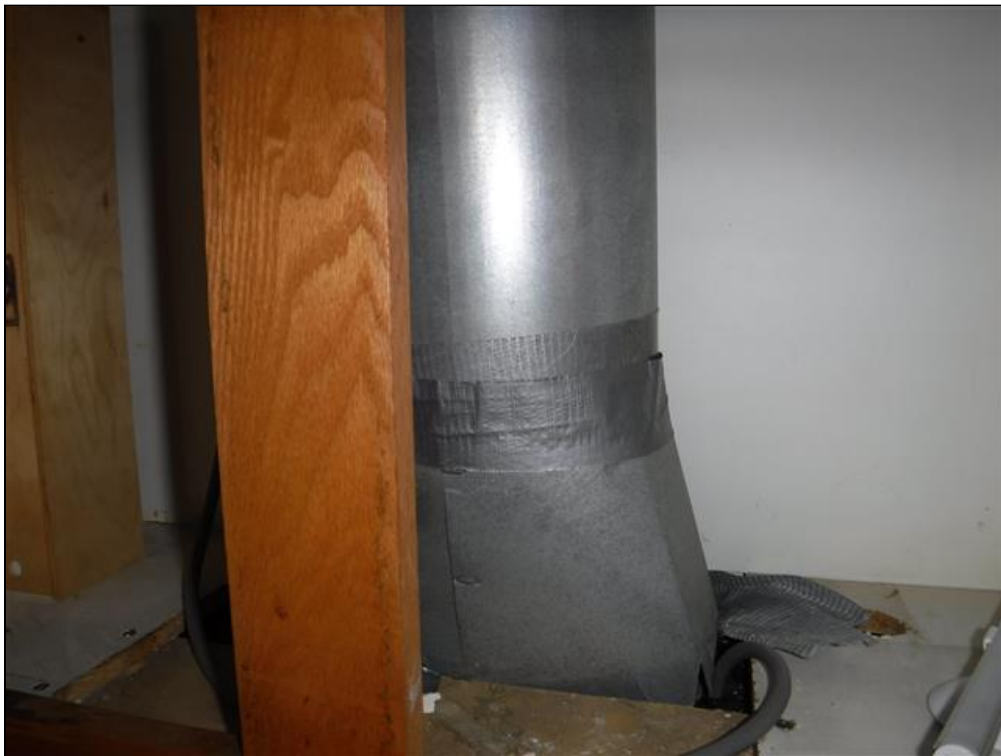
**4.11** The old range hood is still in place. The new microwave is venting on the outside of the cabinet/top of the microwave. There is the ability to route the venting from the microwave up through the old range hood vent. It is recommended to route the venting up through the old hood vent or cap the old venting and remove the ducting.

4.11 Item 1(Picture) Old range hood

4.11 Item 2(Picture) Old range hood

The old range hood is still in place. The new microwave is venting on the outside of the cabinet/top of the microwave. There is the ability to route the venting from the microwave up through the old range hood vent. It is recommended to route the venting up through the old hood vent or cap the old venting and remove the ducting.

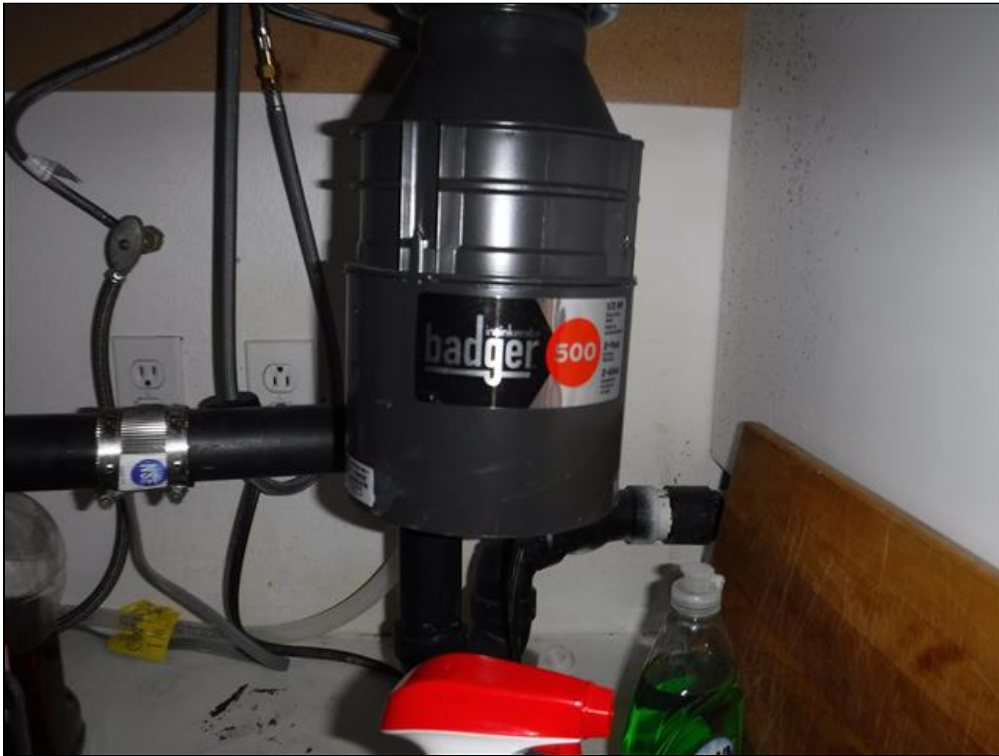
4.12 Garbage disposal under the kitchen sink.

4.12 Item 1(Picture) Garbage/food disposal

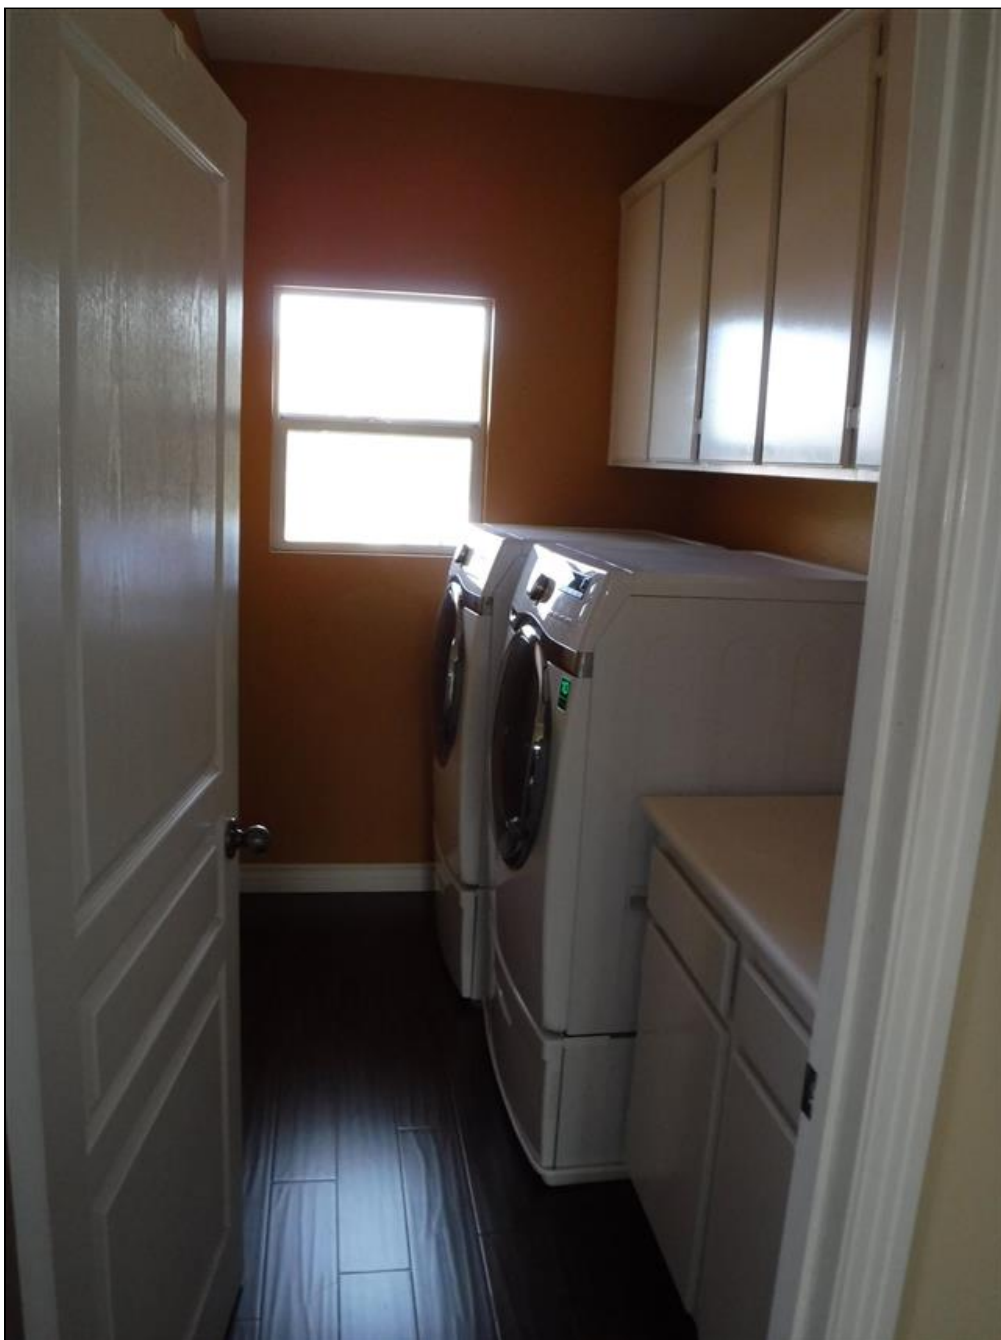
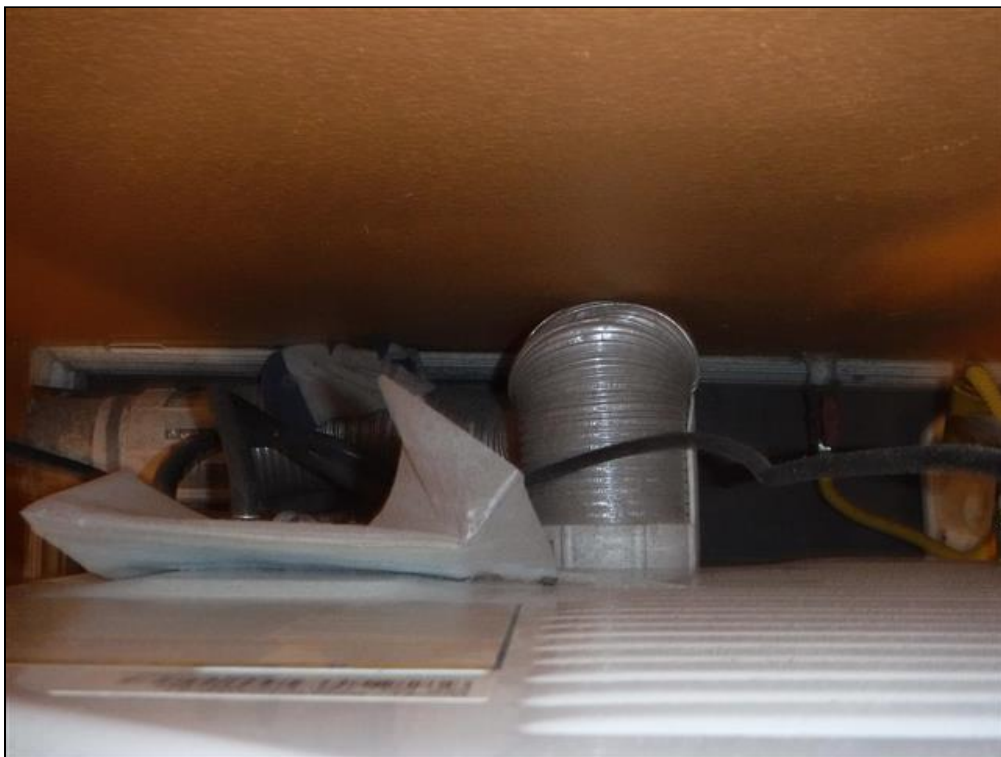
**4.14** There is a lot of lint build up behind the dryer. There could possibly be a hole in the dryer vent metal hose or the connection to the dryer might not be tight. Recommend pulling out dryer and checking all connections and condition of the vent hose.

4.14 Item 1(Picture) Laundry room

4.14 Item 2(Picture) Lint build up behind dryer

There is a lot of lint build up behind the dryer. There could possibly be a hole in the dryer vent metal hose or the connection to the dryer might not be tight. Recommend pulling out dryer and checking all connections and condition of the vent hose.

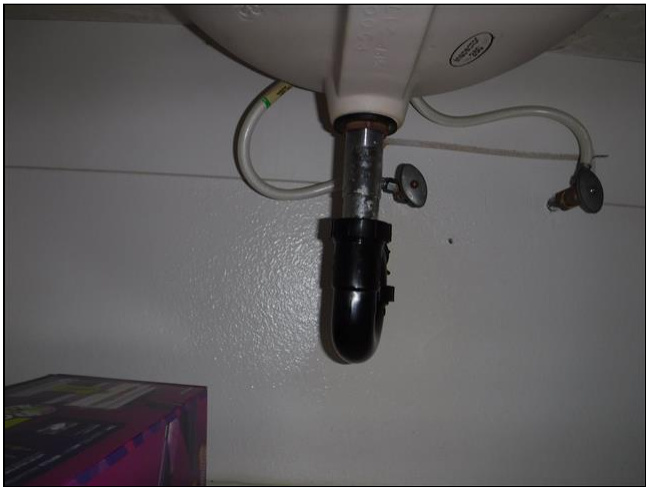
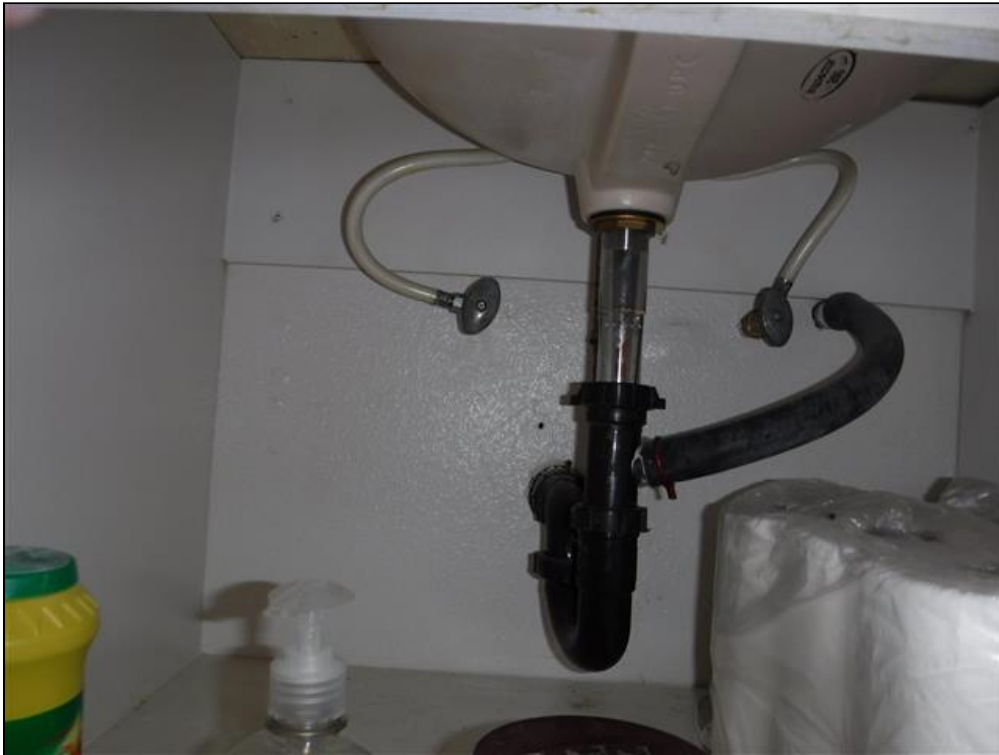
6.6 Plumbing under the sink in the bathroom.

6.6 Item 1(Picture) Bathroom sink plumbing

6.6 Item 2(Picture) Bathroom sink plumbing

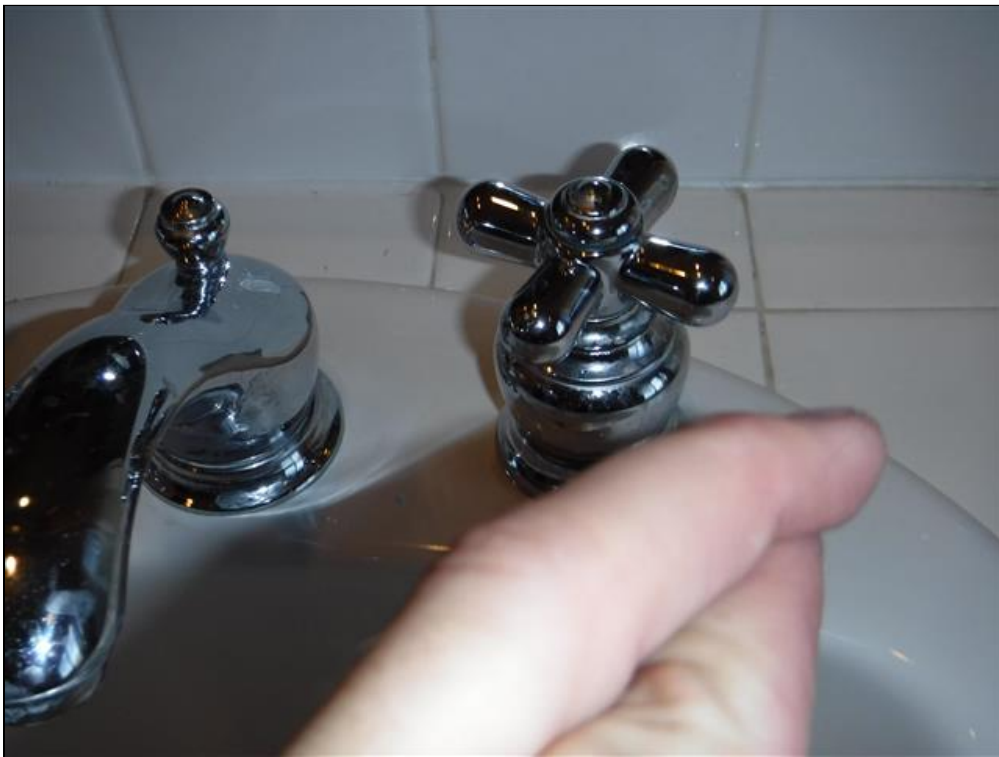
6.7 All cold water fixtures in all three bathrooms are installed backwards. They turn the opposite direction to open and close.

6.7 Item 1(Picture) Master Bathroom sink fixture

All cold water fixtures in all three bathrooms are installed backwards. They turn the opposite direction to open and close.
