# Inspection Report

**Property Address:**  
1234 Park Ave  
San Diego CA 92120

**BHI San Diego / Bailey's Home Inspections**

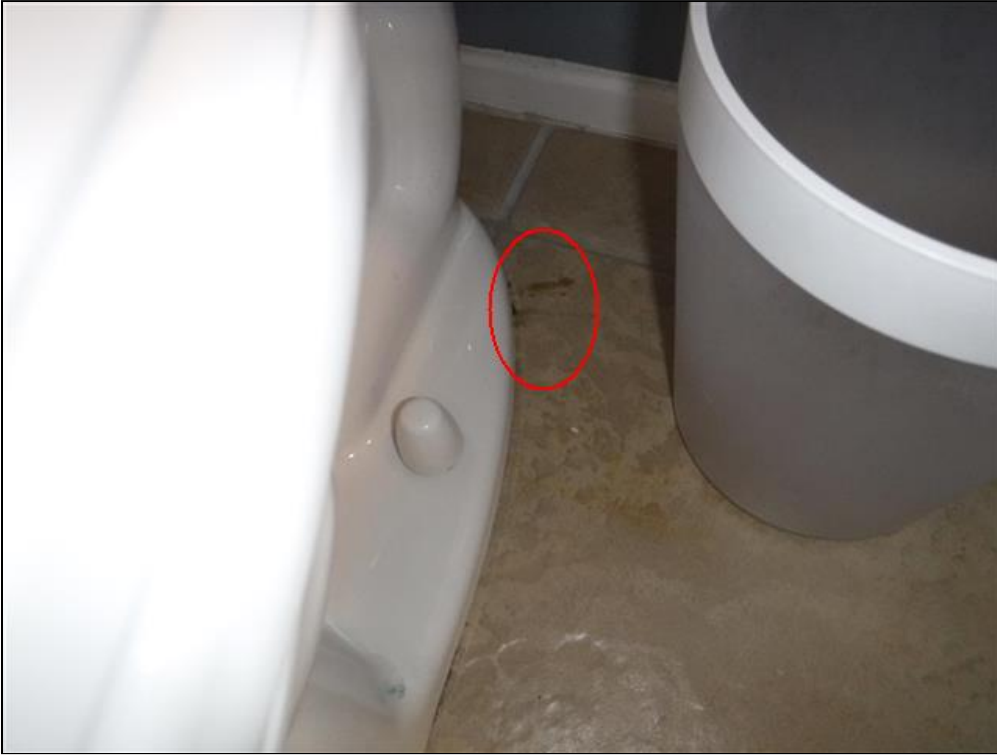
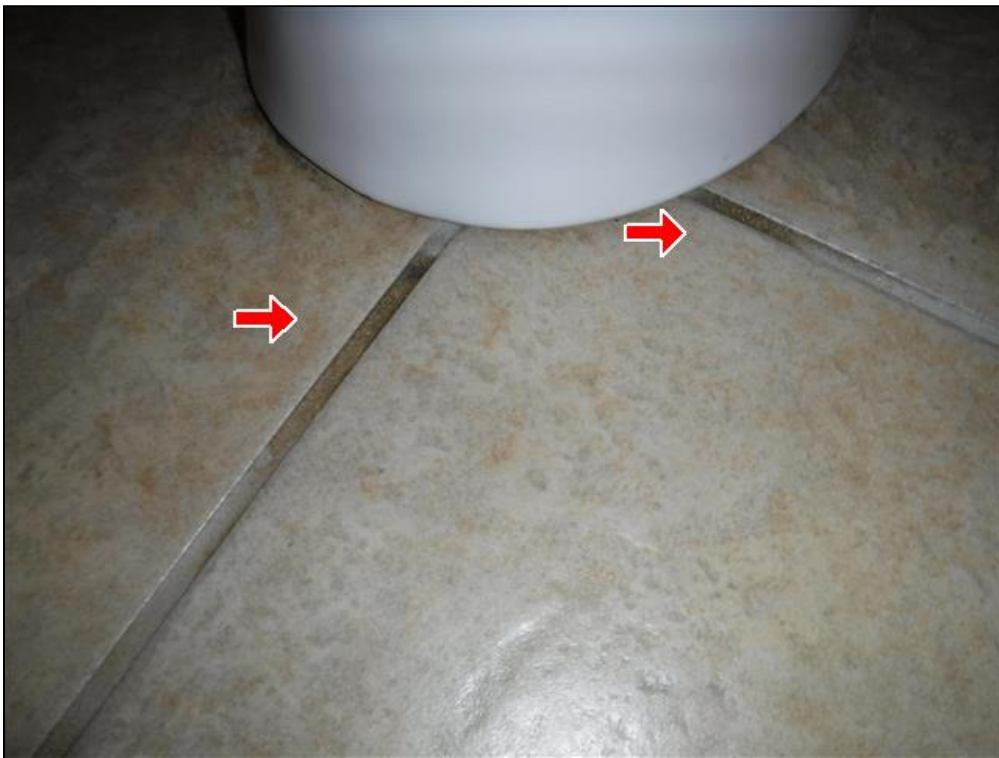
8.1 The seal on the toilet in the half bathroom downstairs is non-operational. The toilet is loose and when moved, water seeps out around the base of the toilet. There are signs of moisture intrusion on the grout around the base of the toilet.

8.1 Item 1(Picture) Moisture at base of half bath toilet

8.1 Item 2(Picture) Moisture stains in grout

The seal on the toilet in the half bathroom downstairs is non-operational. The toilet is loose and when moved, water seeps out around the base of the toilet. There are signs of moisture intrusion on the grout around the base of the toilet.

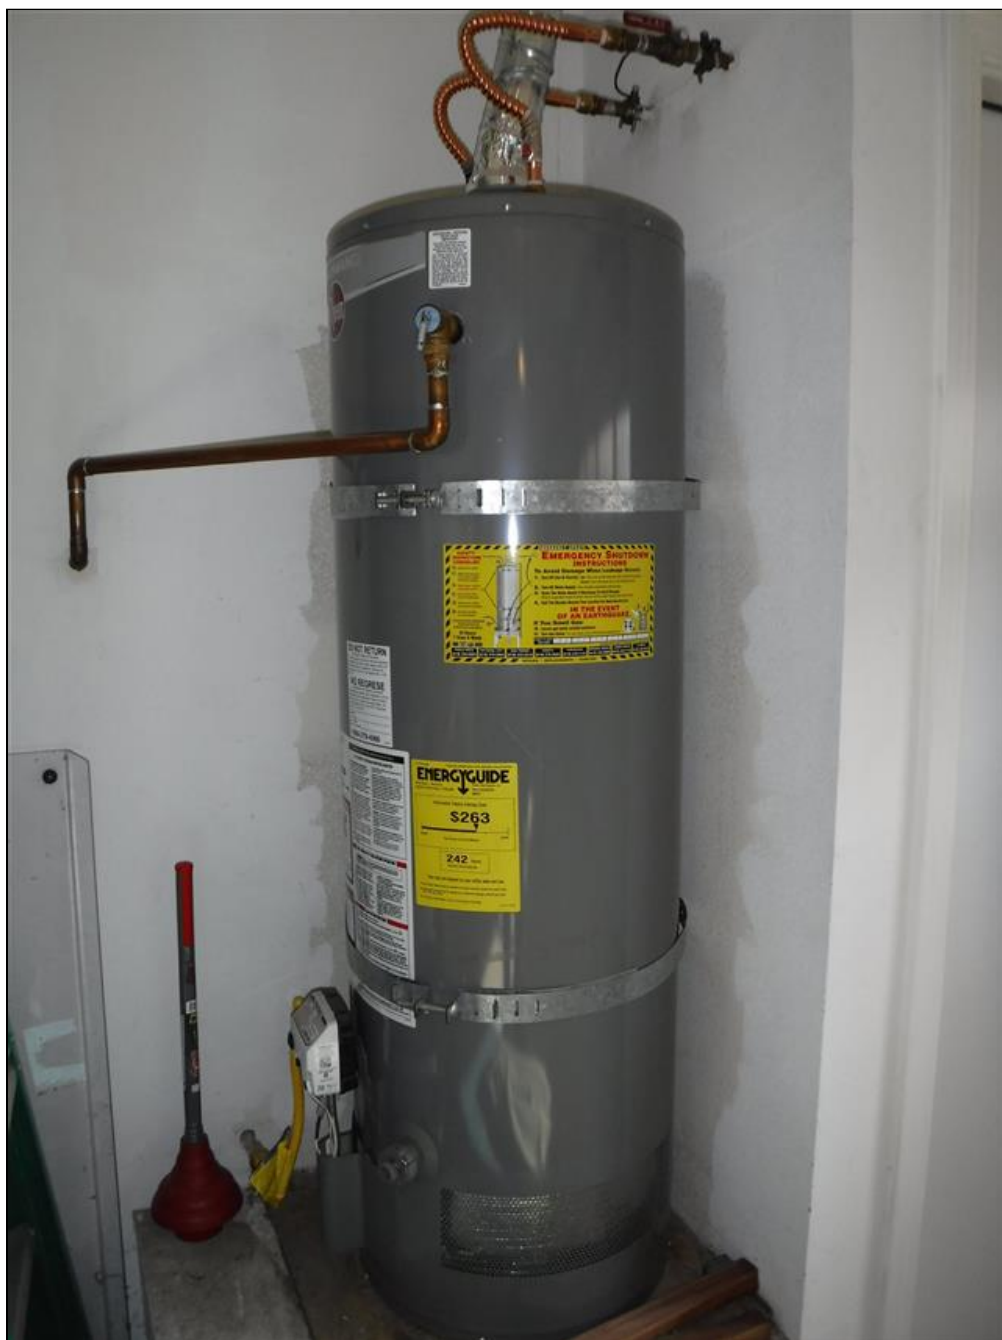
8.2 Water heater was installed in 2015. It is located in the garage.

8.2 Item 1(Picture) Water Heater

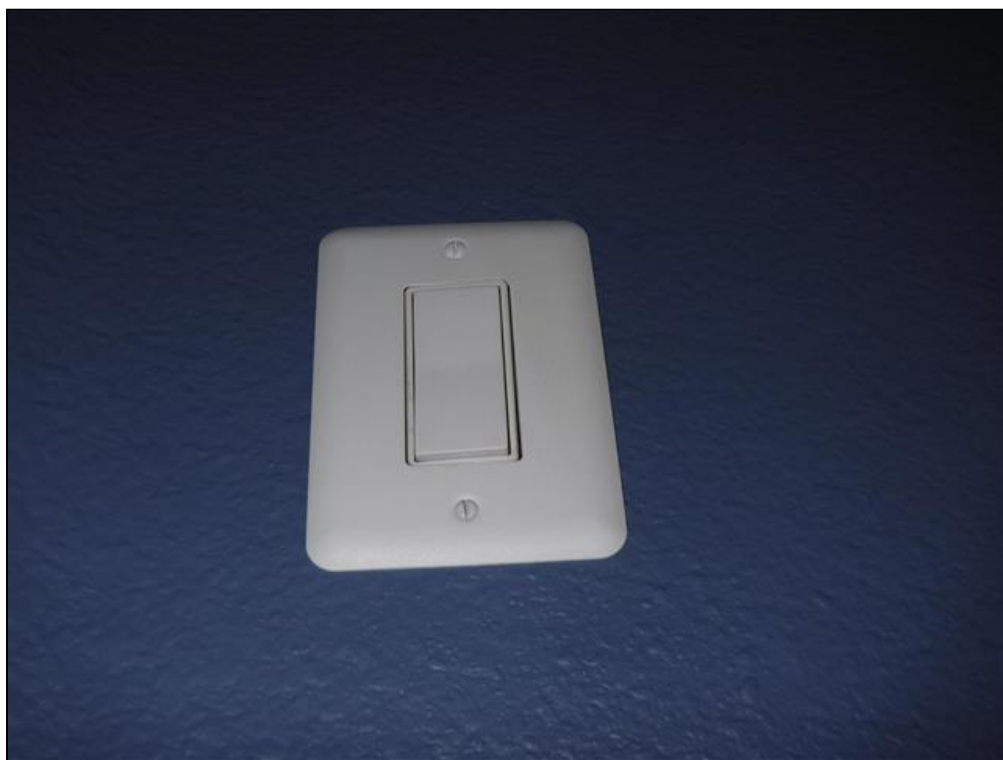
**9.1** This bedroom light switch is loose and needs to be tightened or replaced.

9.1 Item 1(Picture) Bedroom light switch

This bedroom light switch is loose and needs to be tightened or replaced.

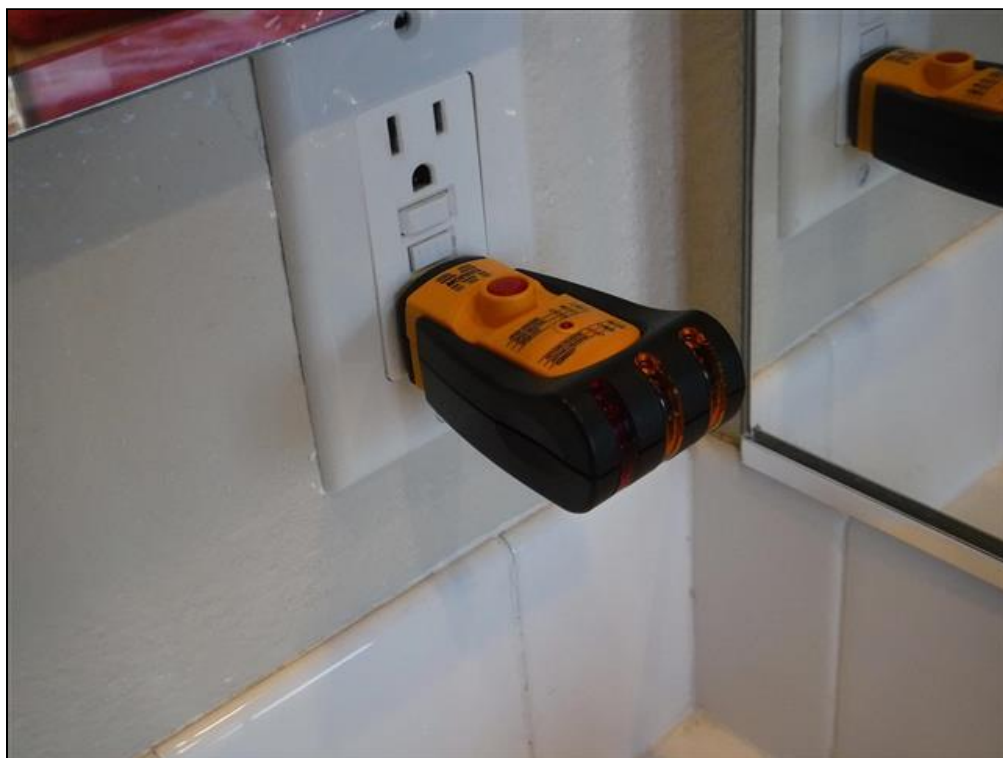
**9.3** All GFCI's are present and operational.

9.3 Item 1(Picture) GFCI Protected

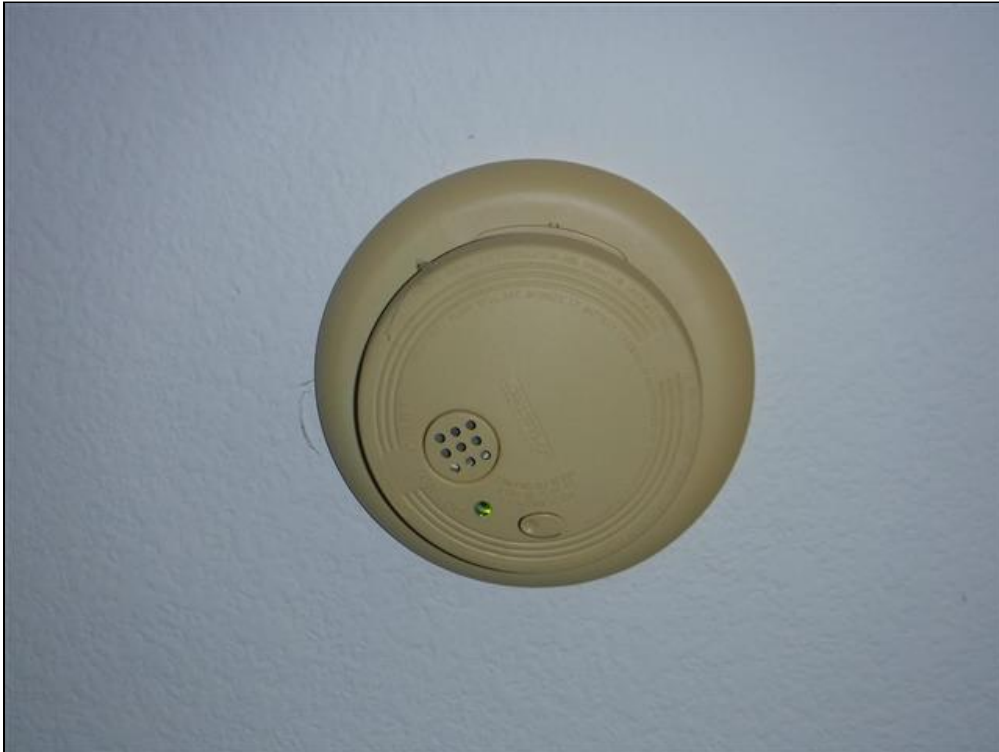
**9.5** The smoke detector should be tested at common hallway to bedrooms upon moving in to home. There are smoke detectors in all bedrooms.

9.5 Item 1(Picture) Smoke detectors

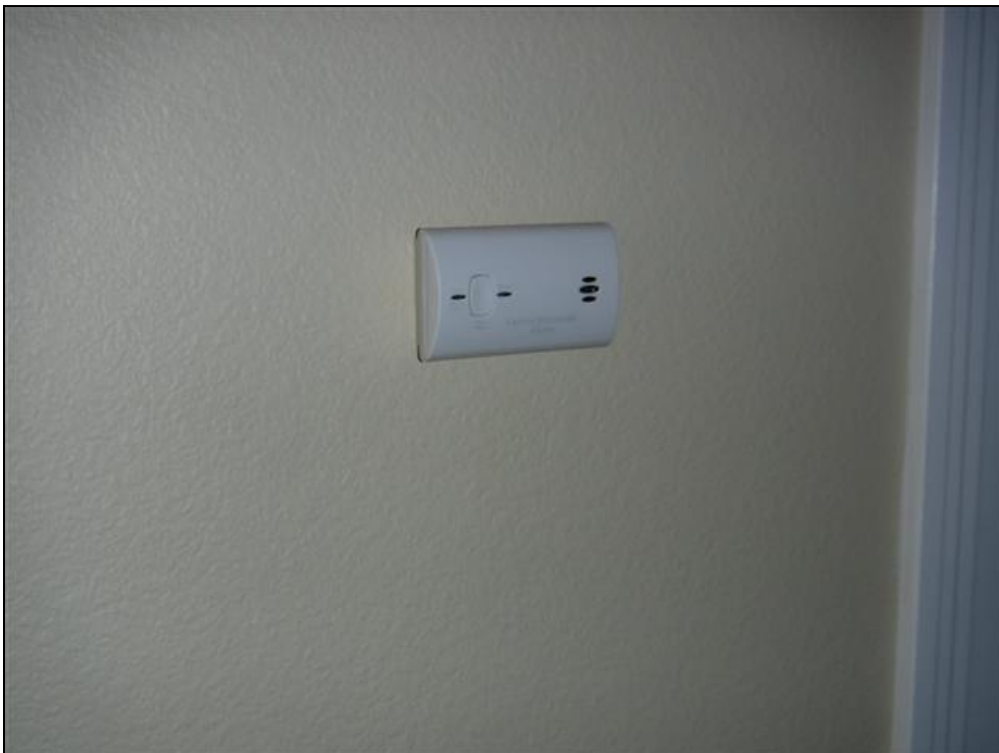
**9.6** There is carbon monoxide in the upstairs hallway as well as in the downstairs hallway by the half bath.

9.6 Item 1(Picture) Carbon Monoxide detectors

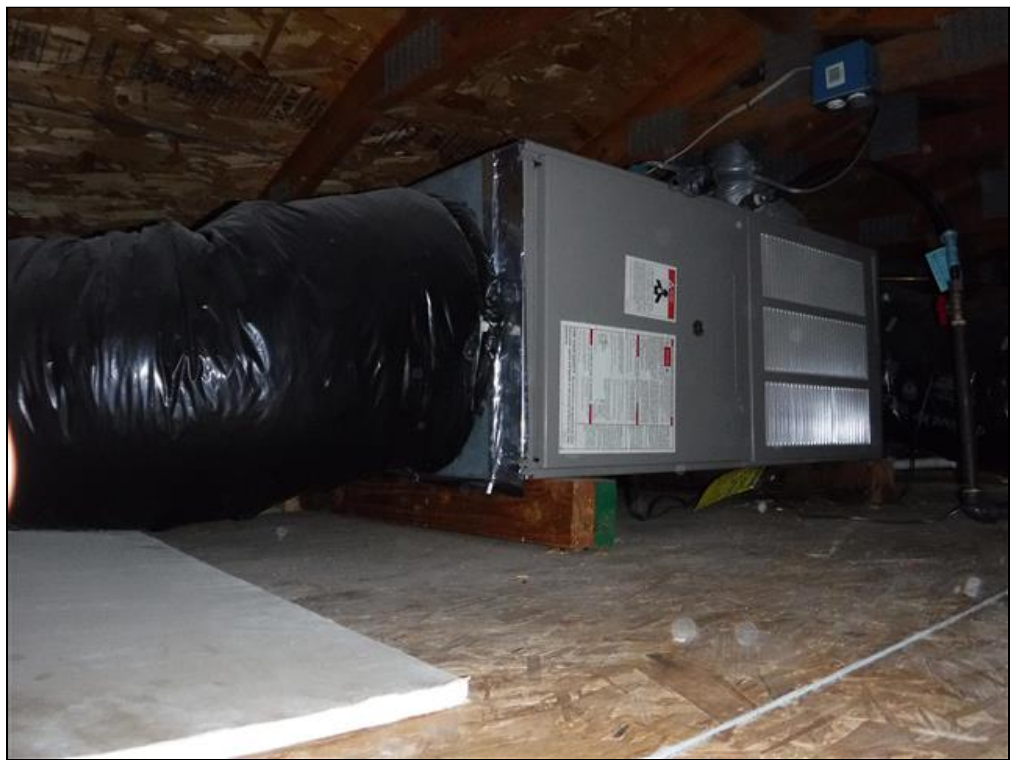
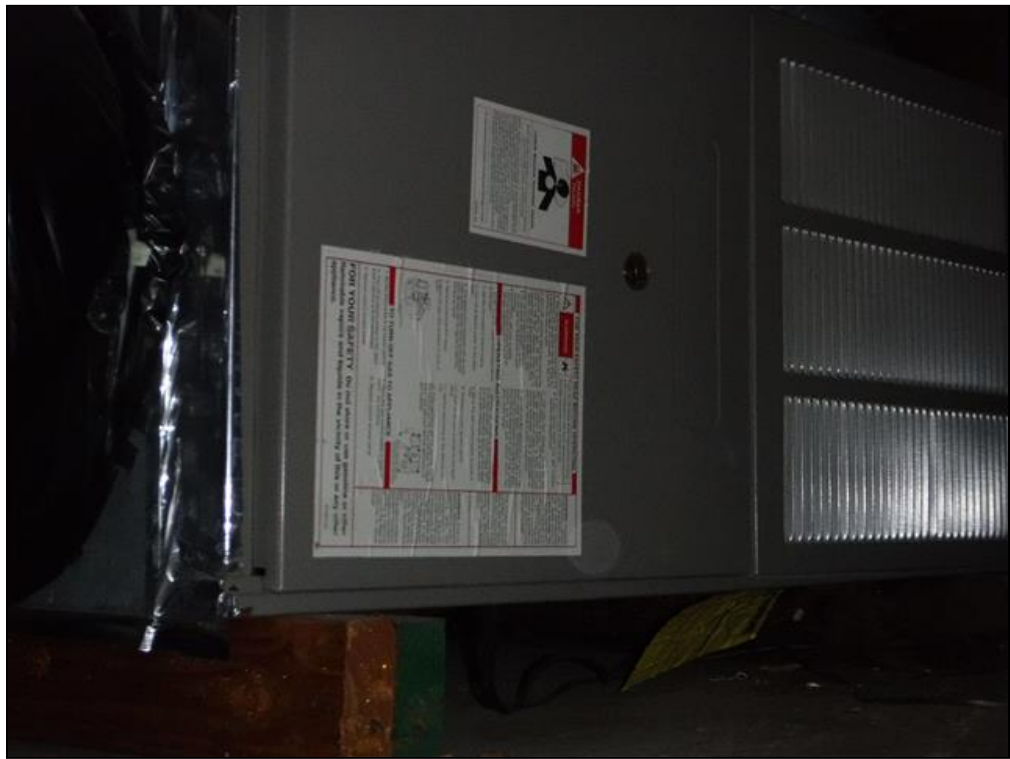
10.0 Furnace is located in the attic.

10.0 Item 1(Picture) Furnace

10.0 Item 2(Picture) Furnace in attic

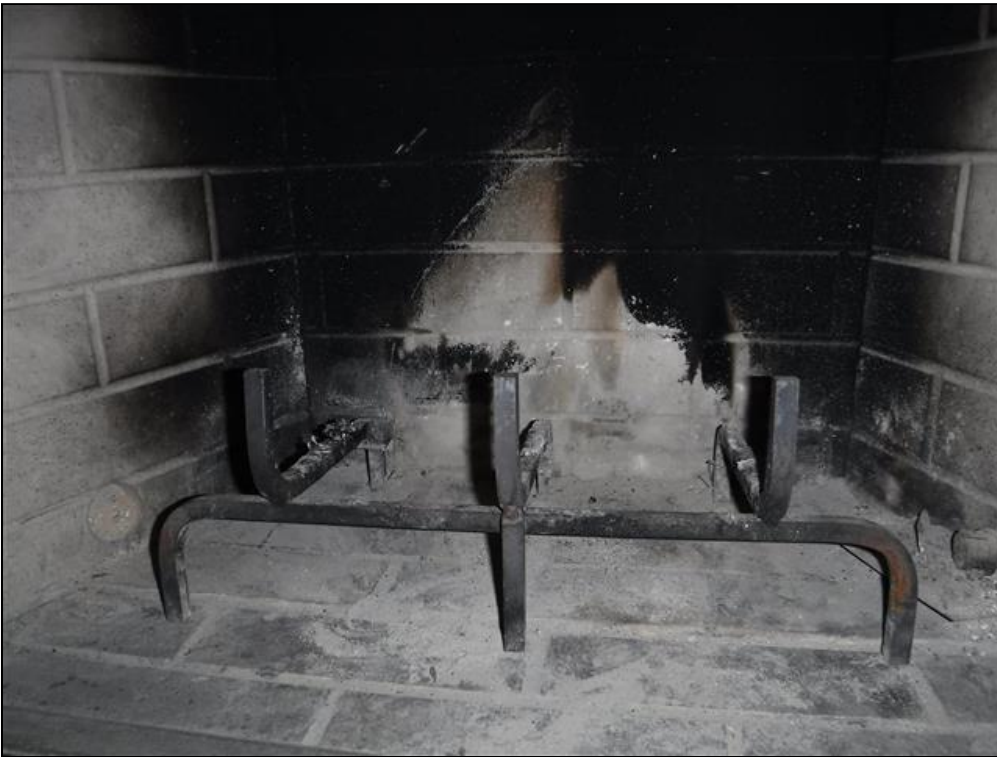
10.5 Fire place in the living room has a lot of soot build up. Recommend getting it cleaned.

10.5 Item 1(Picture) Fire place

10.5 Item 2(Picture) Fire place damper

Fire place in the living room has a lot of soot build up. Recommend getting it cleaned.

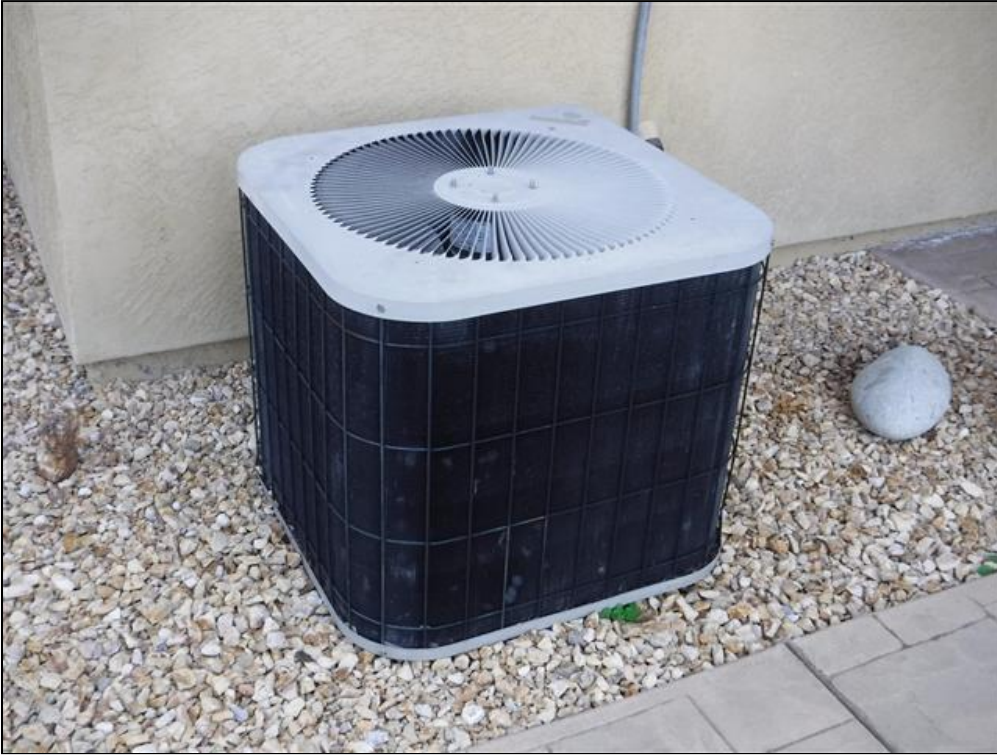
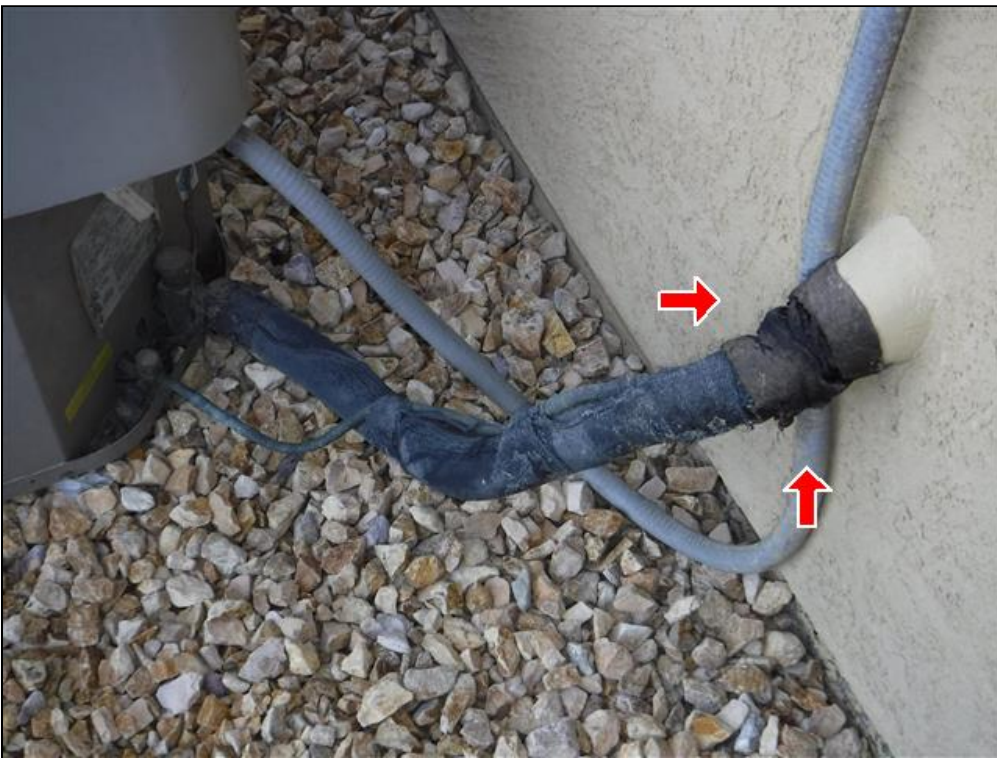
**10.6** The insulation on the cooling line is old and deteriorating. Recommend replacing with new insulation to prevent moisture/leaking.

10.6 Item 1(Picture) Air conditioner

10.6 Item 2(Picture) Insulation on cooling line

The insulation on the cooling line is old and deteriorating. Recommend replacing with new insulation to prevent moisture/leaking.
